Pilot Reported Roughness: Roughness Investigation and Repair

By: Kevin Chee of the Greater Toronto Airport Authority
Michael Gerardi of APR Consultants

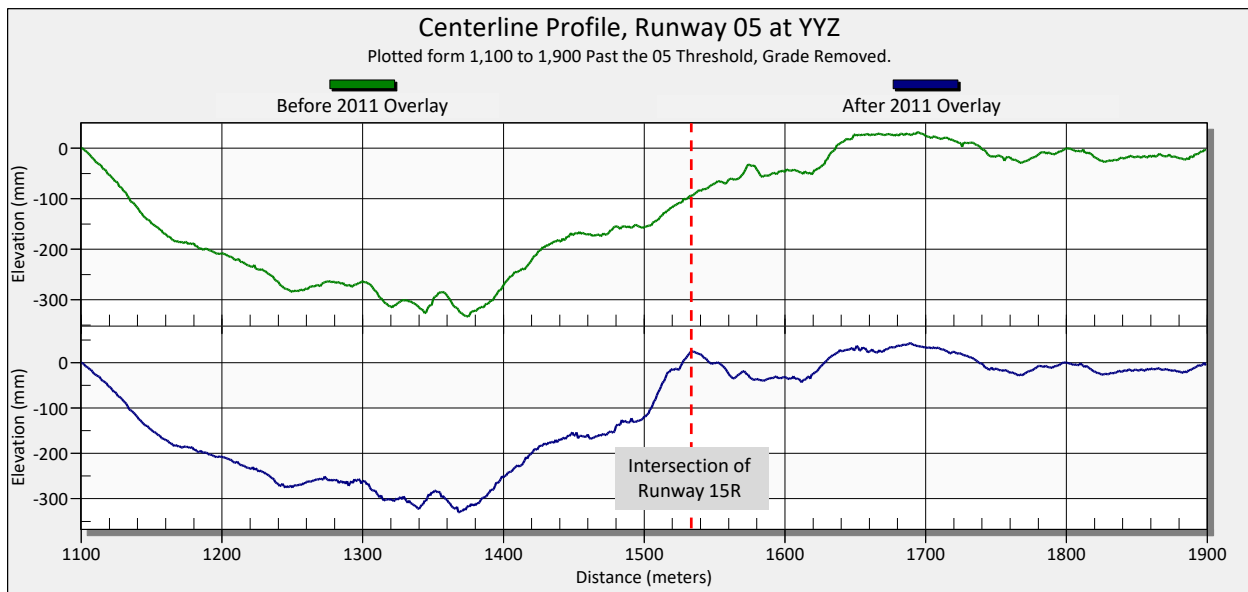
Early in 2011, the Greater Toronto Airport Authority (GTAA) resurfaced Runway 05-23 at Toronto's Lester B. Pearson International Airport (YYZ). Not long after opening the runway, Air Canada began getting pilot complaints of runway roughness when operating from Runway 05-23. The aircraft's Flight Data Monitors began registering excessive loads (1.70g) at the center of gravity of their 777 aircraft in response to roughness at the intersection of Runway 15R. APR was asked to investigate and pin-point the area of roughness, and also to assist the GTAA in developing a repair that would eliminate the bump without compromising needed watershed performance for Runway 15R. Figure 1 illustrates two plots; one of the runway's profile before the overlay and one of the changes created by the overlay. Figure 2 illustrates the aircraft's response to the measured profile in the vicinity of the Runway 15R intersection. Accelerations near 1.0g for this simulation, well over the $\pm 0.40g$ threshold. Please note the undulations (multiple event roughness) on either side of the 15R intersection.

Figure 1. The measured runway profile of Runway 05-23 before overlay (top) versus after the overlay (bottom).

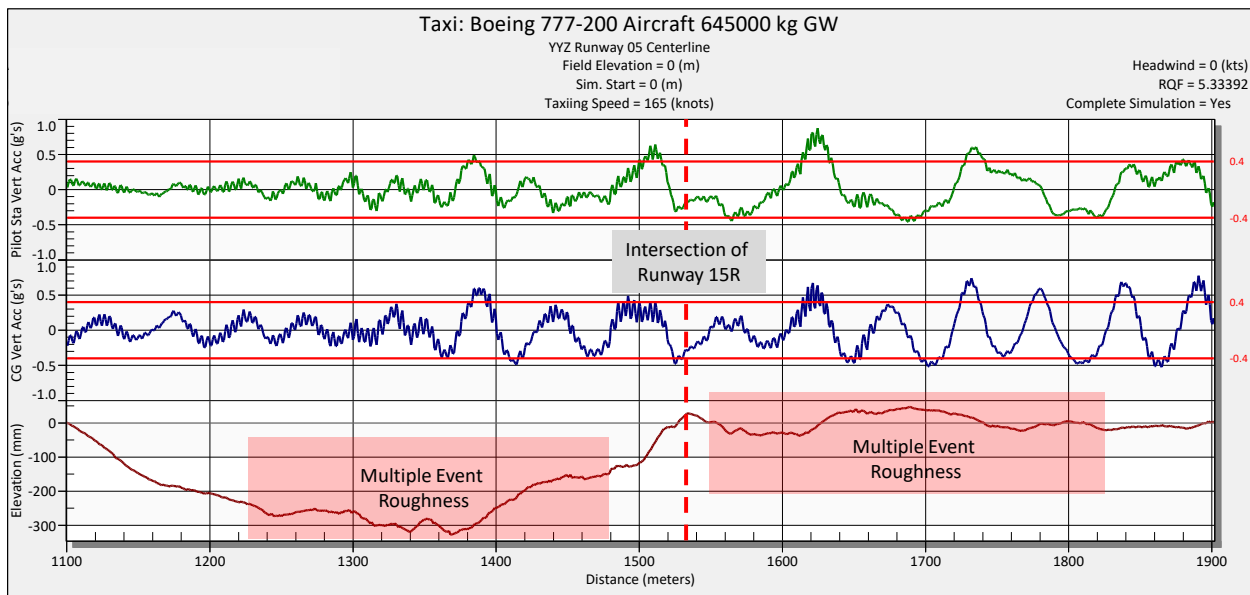
the aircraft did not respond to just one event, the intersection with 15R, but was responding to a series of events that led up to the 15R intersection. The bumps and dips preceding the intersection caused the aircraft to “rebound” from those events as it encountered the up-side of the 15R intersection. Figure 2 illustrates the measured profile of the affected area as measured in 2007 (top) and the new profile, measured after the 2011 overlay. Note the difference in pavement profile located around the 1,540-meter mark.

Figure 2. Aircraft simulation of a 777-200 encountering the intersection of Runway 15R.

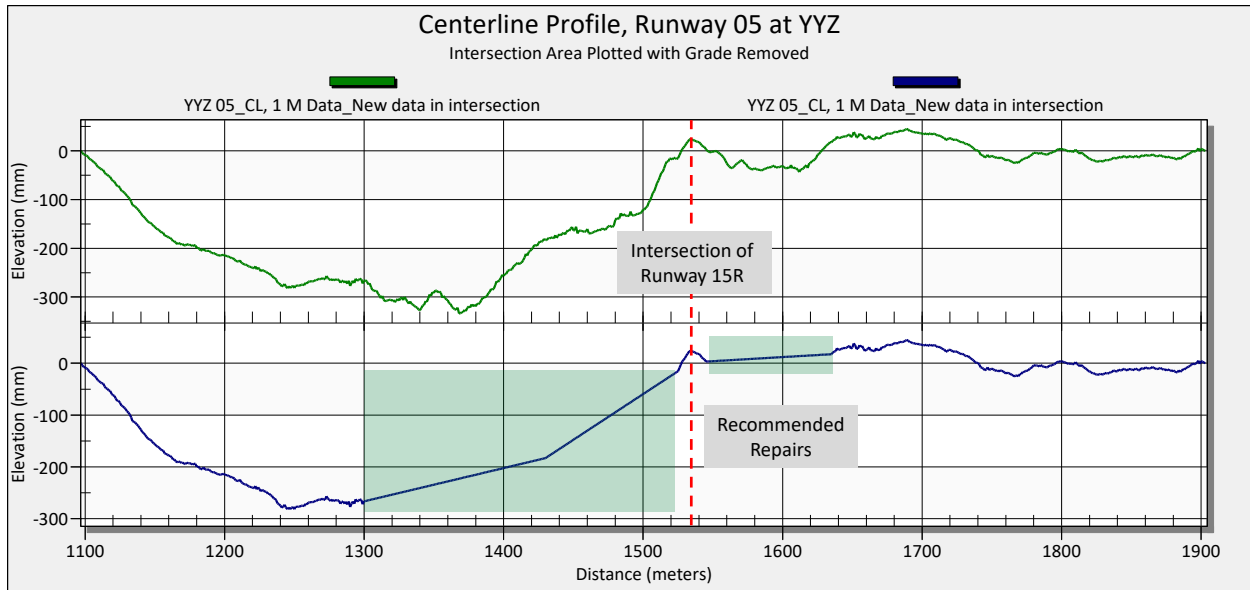
Figure 3. The profile of Runway 05-23 after the 2011 overlay (top) versus the proposed repair designed by APR (bottom).

Once the bump locations were identified, APR began an iterative process of making straight line repairs to the measured profile. This process involved making conservative modifications (analytically) to the profile, then simulate an operation, in this case, a high-speed taxi using a model of a Boeing 777-200. This process is repeated until the desired ride quality is achieved. Figure 3 illustrates the notional changes to the runway's profile (bottom of plot) versus the original profile (top). Once the optimum repair was designed, the repair profile was provided to the GTAA for use by their paving contractor. APR's simulations indicate that the repaired profile yields a dramatic improvement in ride quality for the 777 aircraft. As Figure 4 shows, the aircraft's accelerations are well within the .40g threshold of acceptability.

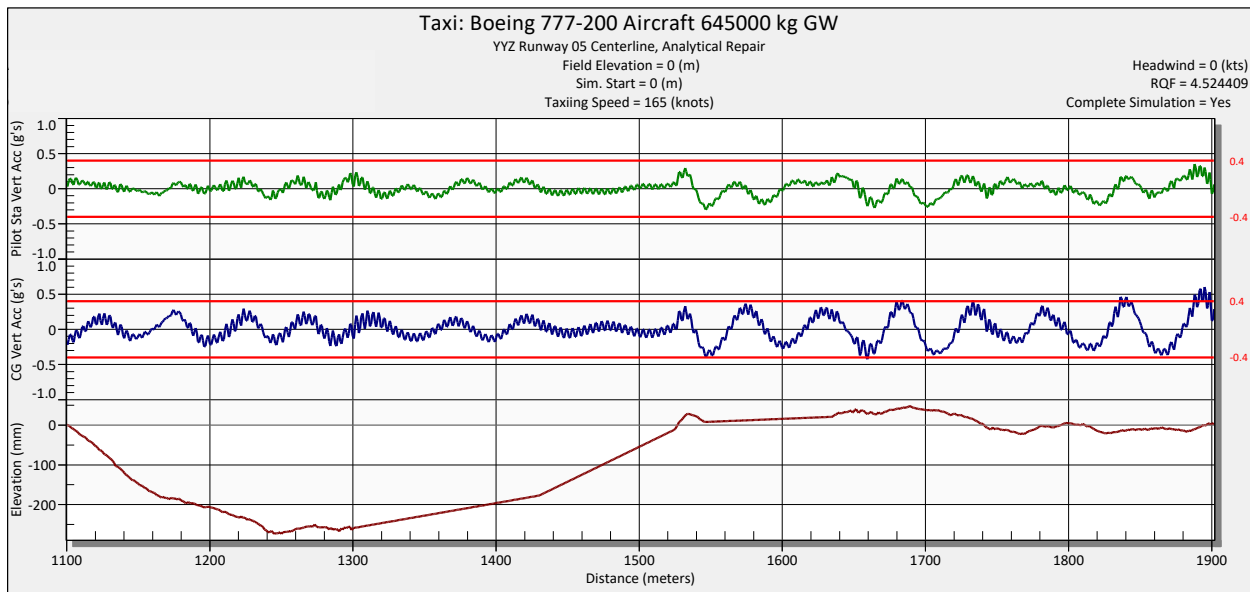
Figure 4. Aircraft simulation of a 777-200 performing a constant-speed taxi over the *repaired* profile with dramatically improved results.

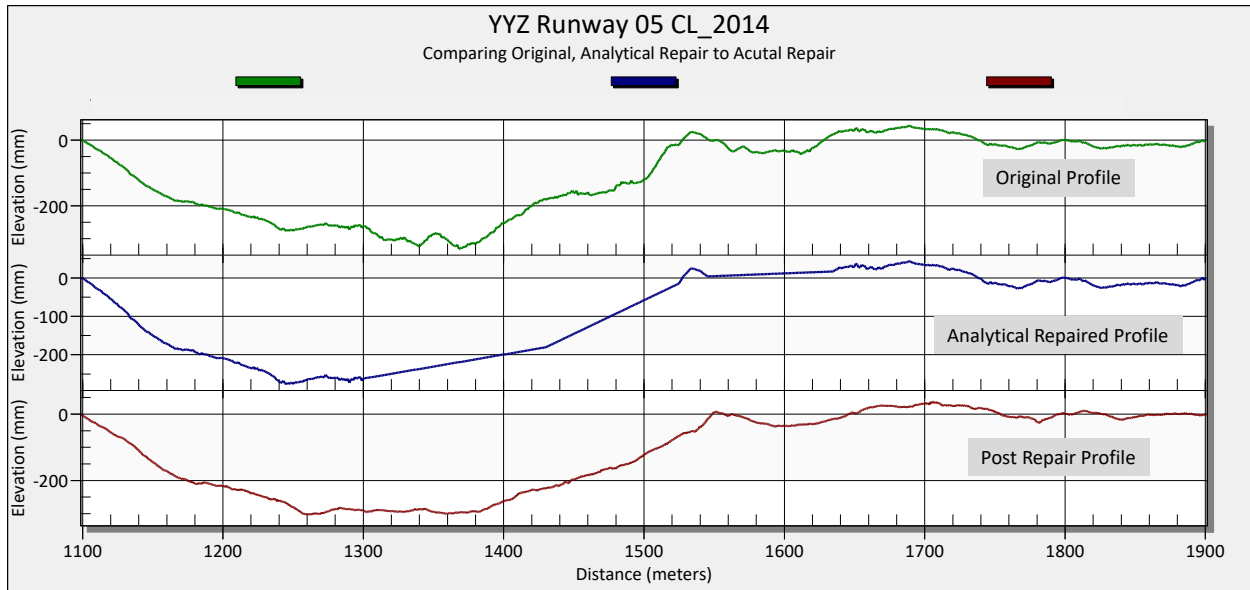
Figure 5. The original 2011 overlay profile (top) compared to APR's engineered design (middle) and the as-built repair (bottom).

Later in 2014, APR was asked to re-assess Runway 05-23 to update the pavement management program at YYZ. Using the Auto Rod and Level, three lines of survey were measured of this runway. Figure 5 plots the post repair profile of the affected area compared to the original problematic profile and the analytical repair APR provided to the GTAA. When assessing the ride quality of the actual repair, the ride quality improved significantly, eliminating pilot complaints (Figure 6).

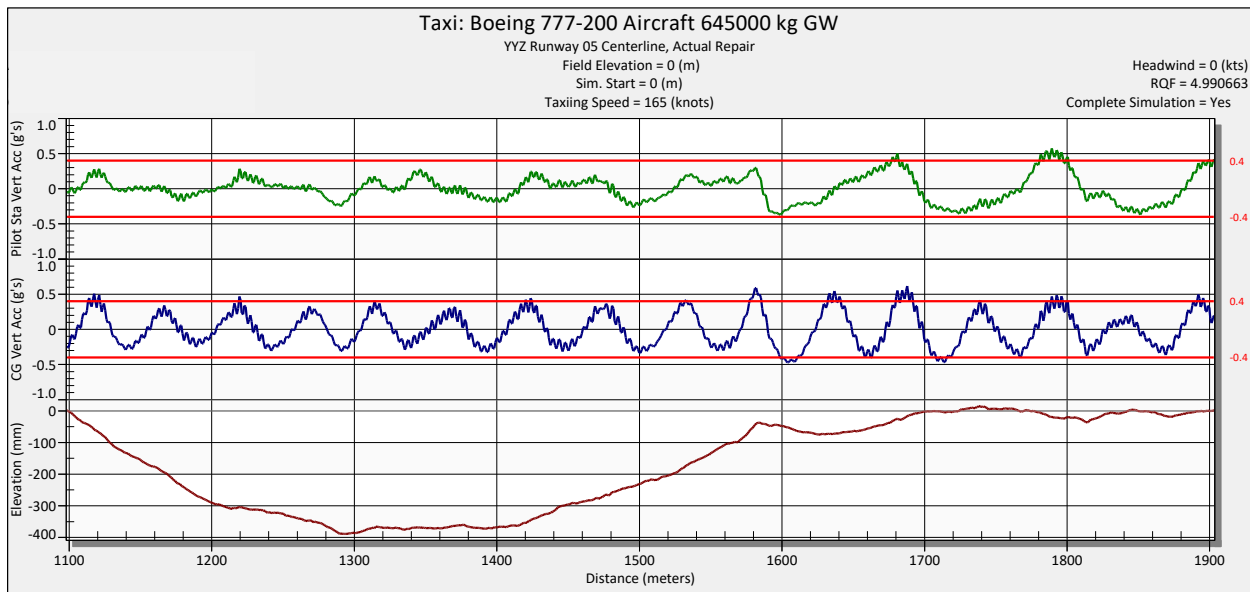
Figure 6. Aircraft simulation predicts significantly improved ride quality for the newly repaired profile.
