Increasing the Value of Airport Pavement Management

By Michael Gerardi

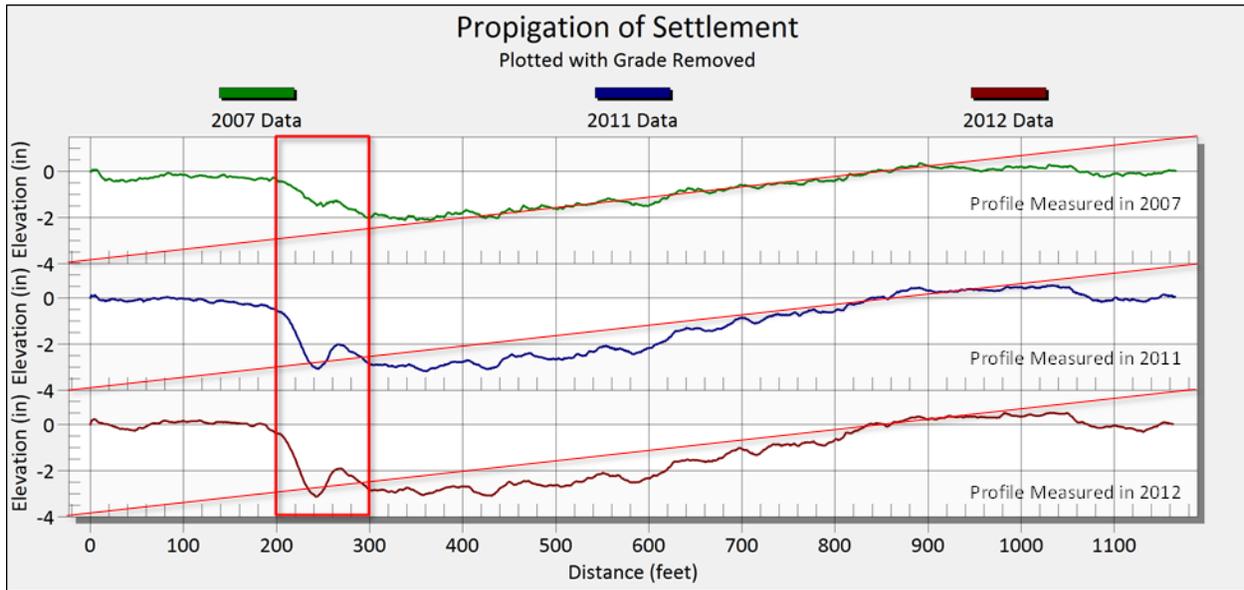
Figure 1. The measured pavement profile of Case Study One. Five years of profile comparison.

Case Study One illustrates that, over time, this runway has developed a dip in the runway's keel section that has been getting progressively deeper. This particular runway is an asphalt pavement built in a relatively marshy environment. This figure shows the plotted centerline profile measured at three different points in time. The top portion of the plot was measured in 2007. The middle portion of the plot was measured in 2011, and the lower portion of the plot was measured in 2012. The red diagonal line helps show the profile shape change along an 800-foot section. The primary settlement dip is located at the 240-foot point.

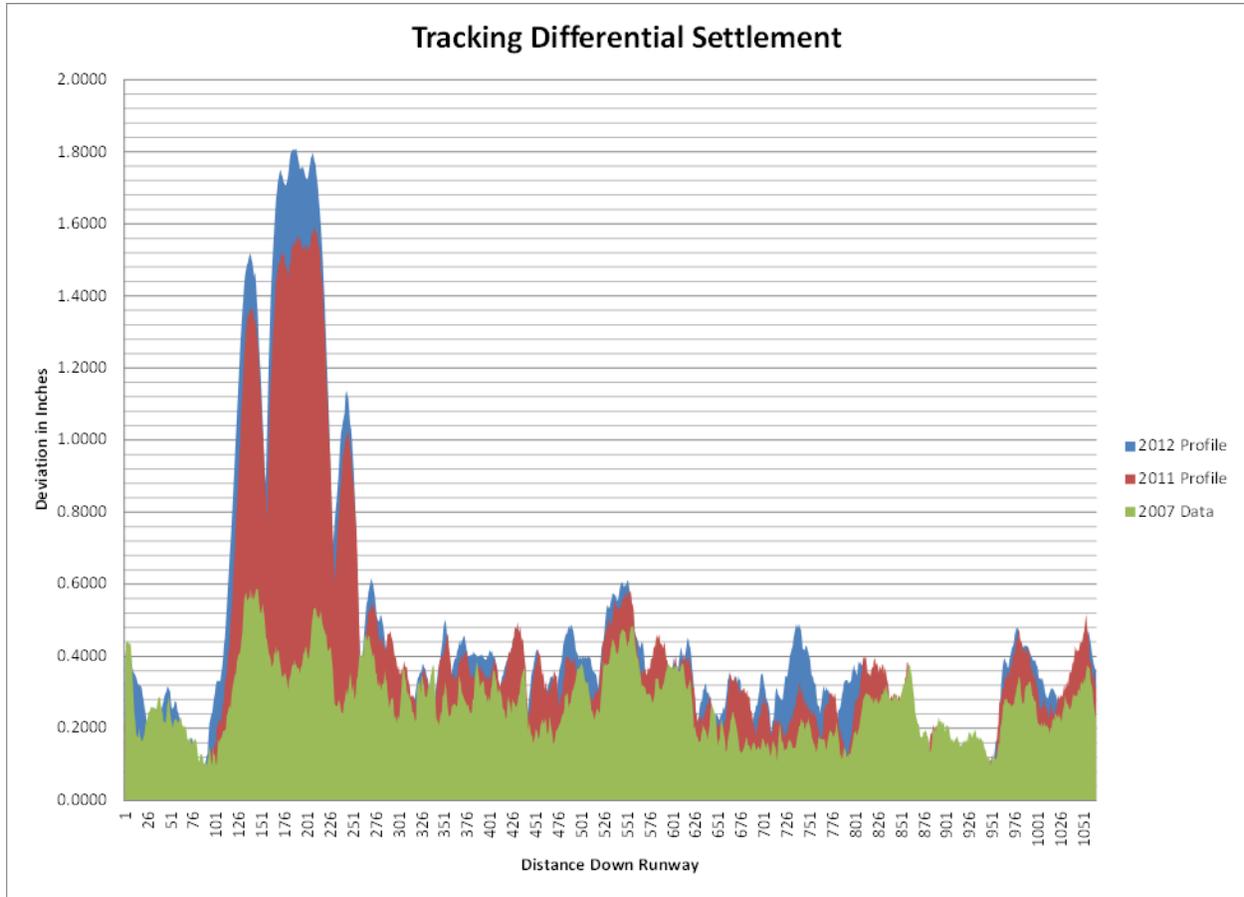
Figure 2. Tracking the profile changes from year to year.

Figure 2 plots the deviations from a straightedge for that section of measured profile. The green area plots the deviations when evaluating the 2007 profile data. The red area plots the deviations when evaluating the 2011 profile data, and the blue area plots the deviations when evaluating the 2012 profile data. This chart helps illustrate the profile's rate of change. This rate of change information is important in determining when to make pavement repairs.

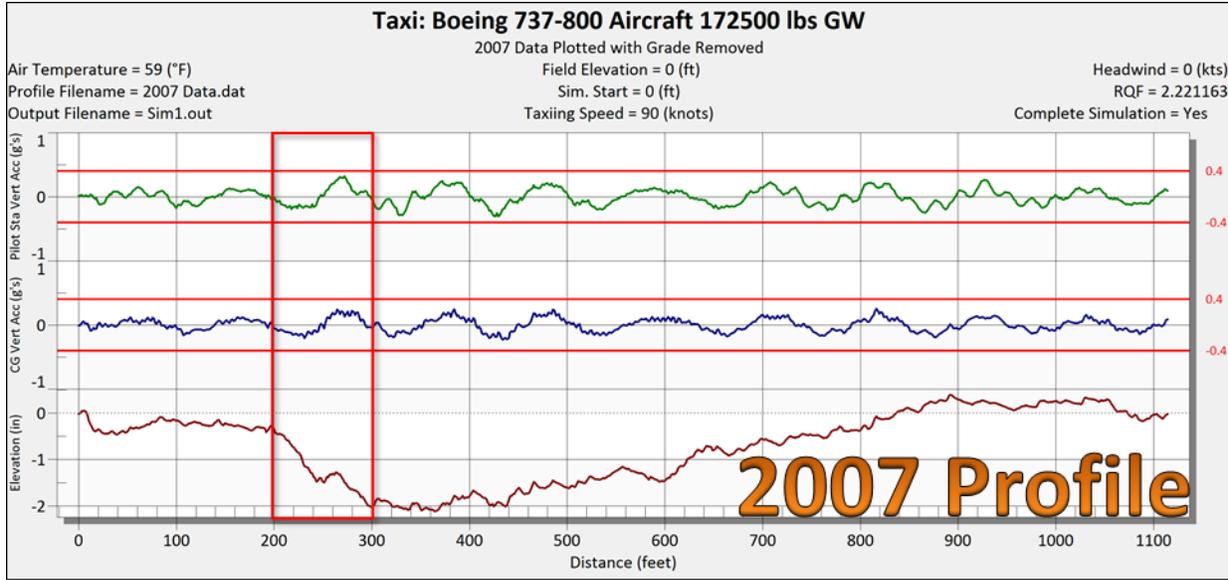
Figure 3. Aircraft simulation shows acceptable responses to the 2007 baseline profile.

Figure 3 is a plot that depicts the results of a Boeing 737-800 constant speed taxi simulation at 90 knots using the profile data measured in 2007. As you can see, the accelerations (top and middle traces on this plot) do not show any areas that exceed the .40g threshold for accelerations. In other words, the pavement had no areas of roughness in 2007.

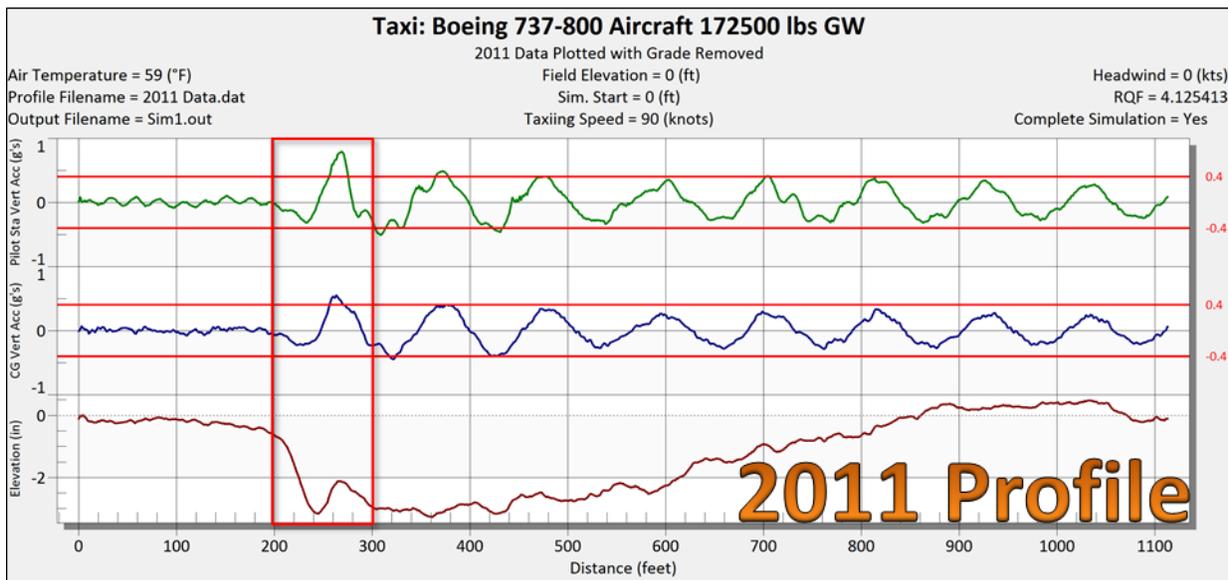
Figure 4. Same simulation conducted on the 2011 profile. Roughness is beginning to generate unwanted aircraft response.

Figure 4 depicts the same simulation (737-800 90-knot constant speed taxi test) only this time it is conducted on the profile data measured in 2011. You can see in the bottom trace that the dip is a bit deeper, and that the aircraft response is now predicted to exceed the .40g threshold of acceptability. This area is now considered to be rough.

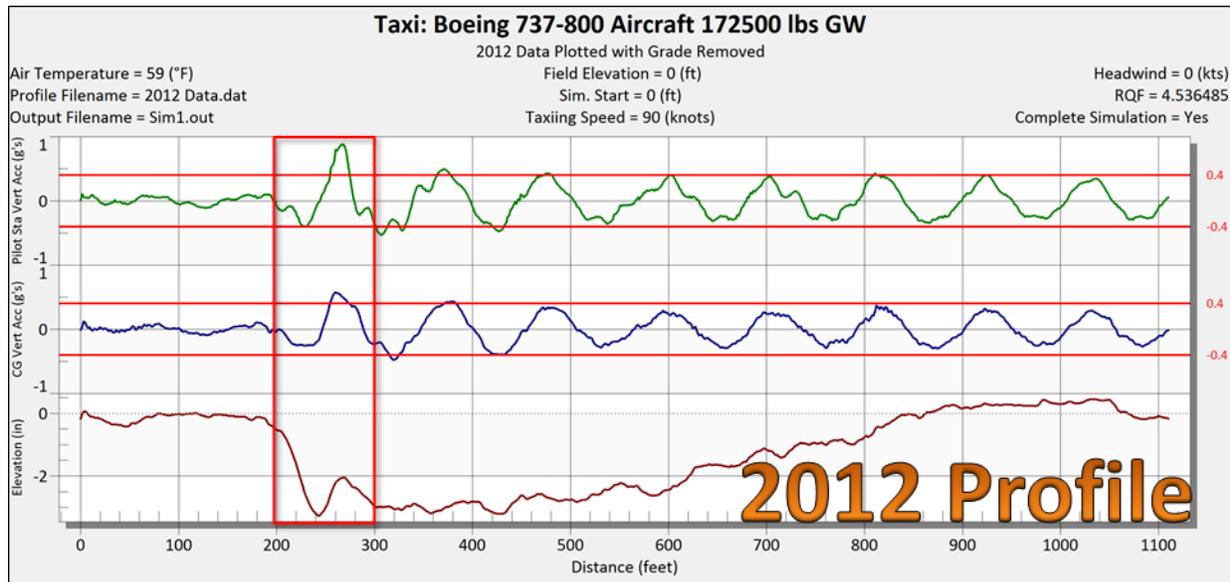
Figure 5. Aircraft simulation now characterizes the ride quality of this profile to produce "significant" aircraft response.

Here again in Figure 5, the 737-800 performs a 90-knot constant speed taxi. This time it is conducted on the profile measured in 2012. The dip is now a bit deeper and the aircraft response is noticeably worse than it was in 2011.

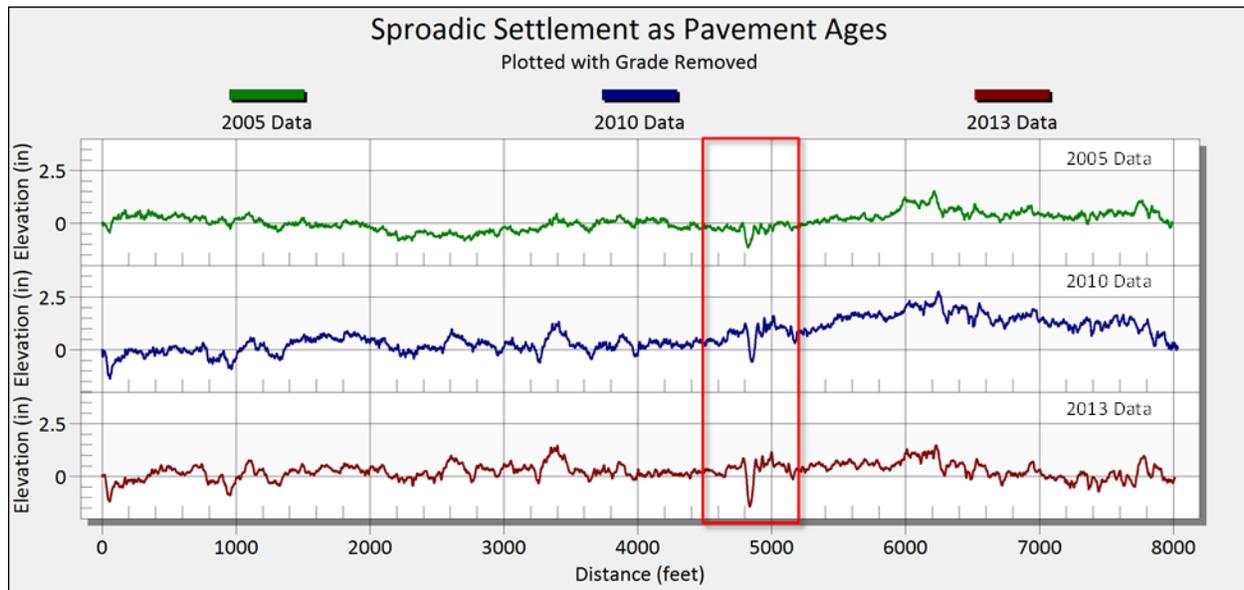
Figure 6. The measured pavement profile of Case Study Two. Eight years of profile comparison.

The second case study is based on a PCC runway that was constructed around 2004-2005. Profile measurement, used as a standard component of the airport's pavement management program, began to detect settlement at approximately 4,900 feet. As seen in Figure 6, the settlement, in this case, is due to sub-surface tunneling. This figure plots the runway's centerline profile measured at three different points in time; 2005 (top), 2010 (center) and 2013 (bottom).

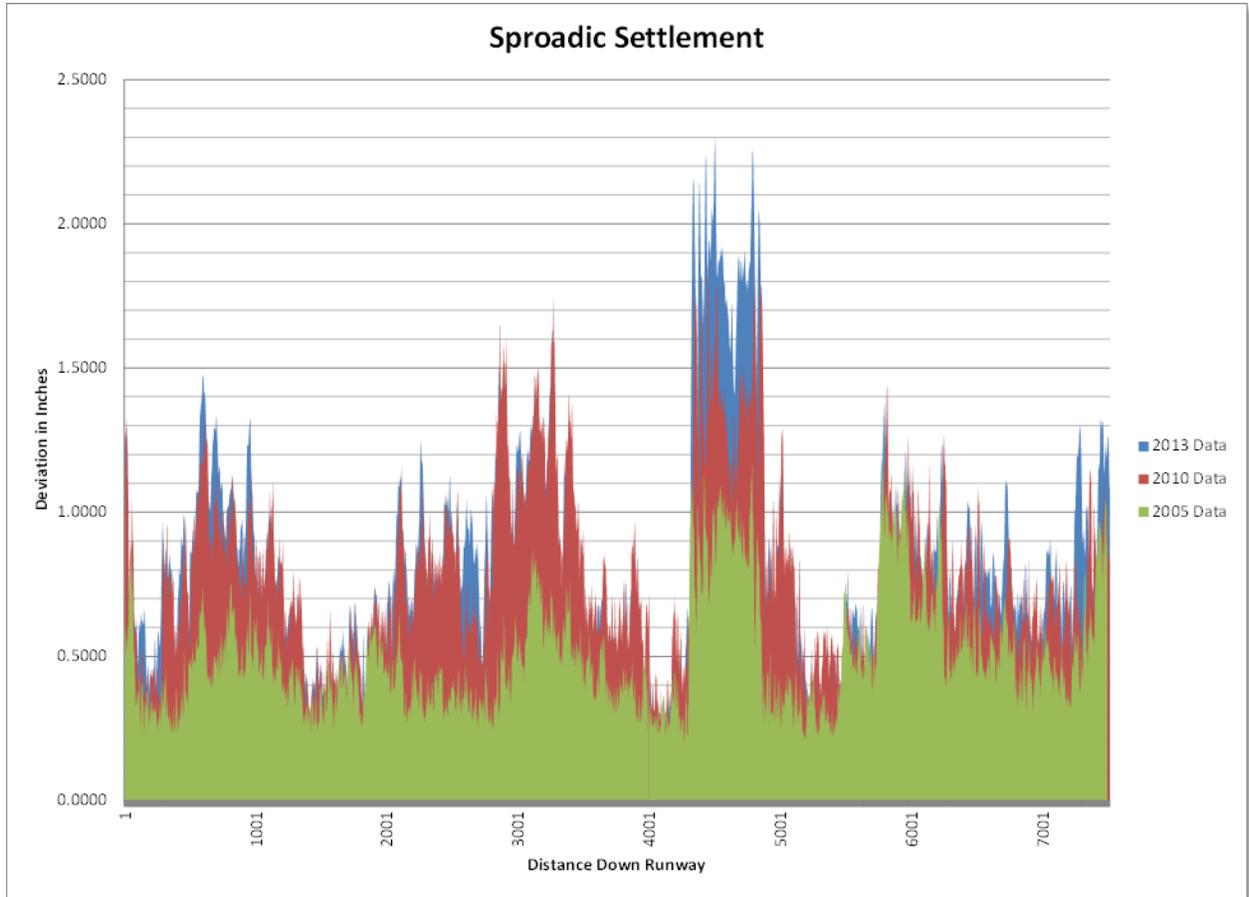
As in the previous case study, Figure 7 helps track the rate of change when comparing the maximum deviations to a straightedge for each set of profile data. Here, you can see sporadic settlement throughout the profile. For example, when you see blue reaching higher than the red, that indicates that the deviation to the straightedge was larger in 2013 than it was in 2010. The tunneling settlement is evident between 4,000 and 5,000 feet.

Figure 7. Tracking the profile changes of the runway used in Case Study Two from year to year.

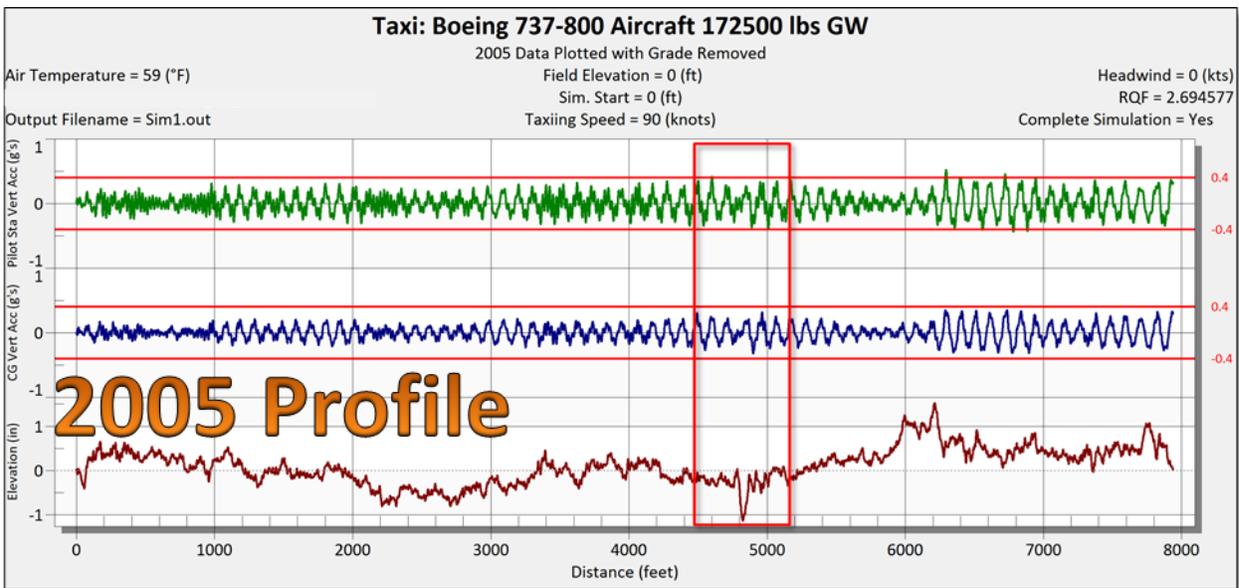
Figure 8. Aircraft simulation predicts acceptable responses to the 2005 baseline profile.

Figure 8 depicts a 90-knot constant speed taxi simulation of a Boeing 737-800 on the 2005 profile data. As you can see, ride quality through the area of settlement is predicted to be within acceptable limits.

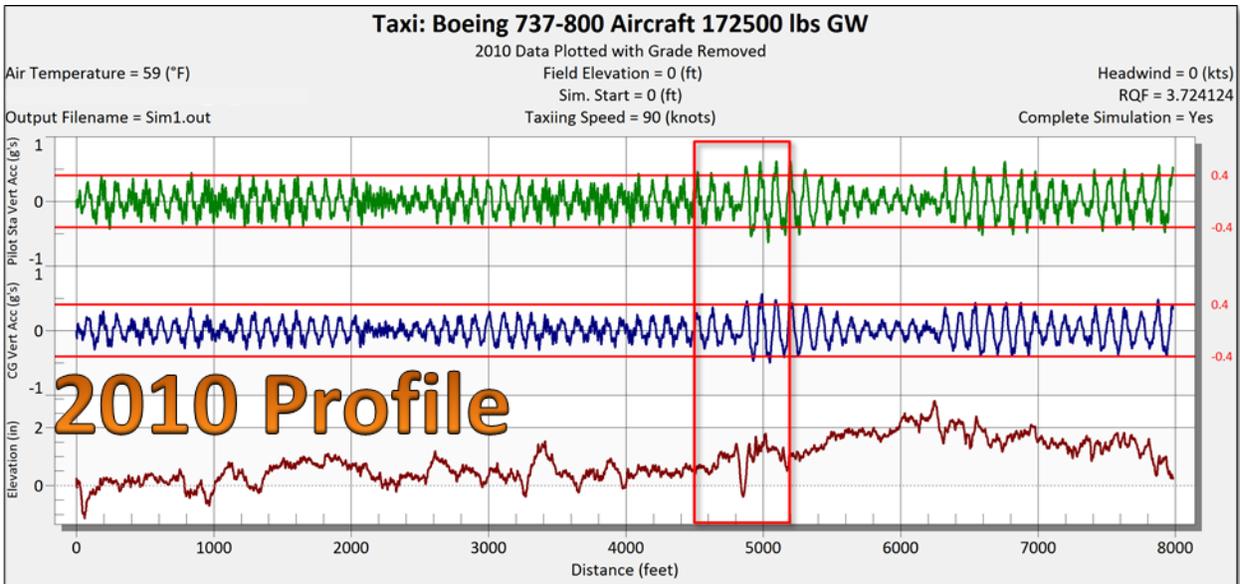
Figure 9. As the settlement continues, ride quality suffers. Cockpit and CG responses exceed .40g.

Figure 9 depicts the same simulation as the previous figure, only this time on profile data measured in 2010. Both the Cockpit (top portion) and the Aircraft Center of Gravity Acceleration (middle portion) predict excessive response as it encounters the dip area which is increasing in depth.

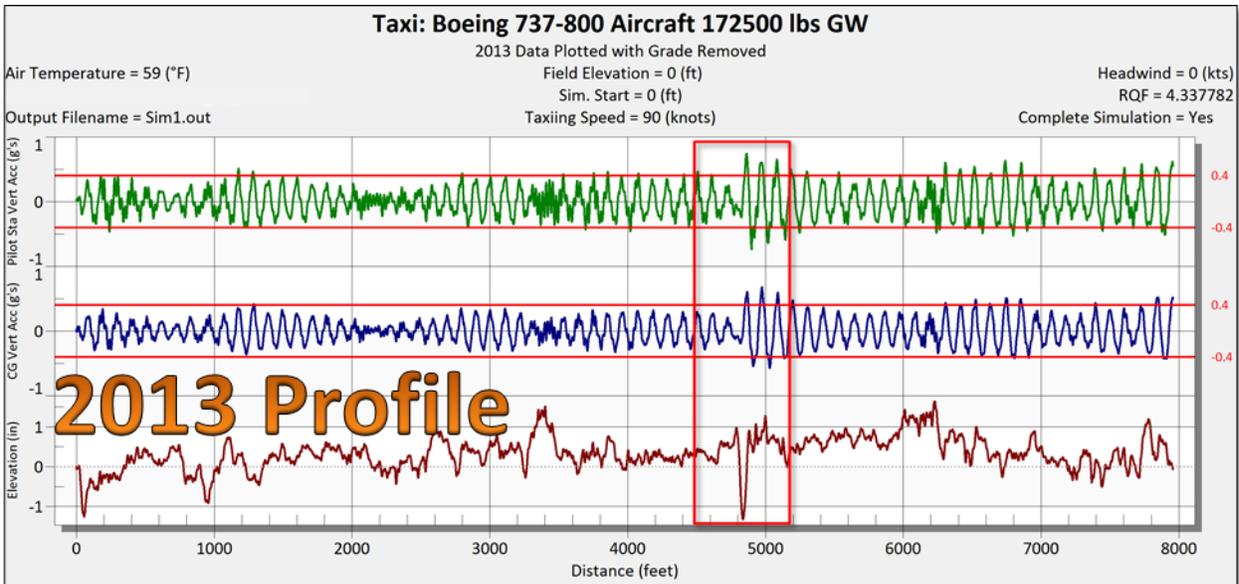
Figure 10. In year eight of the study, ride quality becomes excessive when tested.

Finally, Figure 10 shows that by 2013 the dip has become dramatically deeper (bottom portion). Both the pilot's station and aircraft center of gravity predict that the aircraft response has deteriorated significantly since 2010. Increased aircraft response means that dynamic loading is increasing as well. Continued exposure to this loading environment will affect the localized pavement's useful life.
